Ogden Air Logistics Center

Low Hydrogen
Embrittlement (LHE)
Zn-Ni Plating
Qualification and
Implementation on
Landing Gear
Components

August 2012

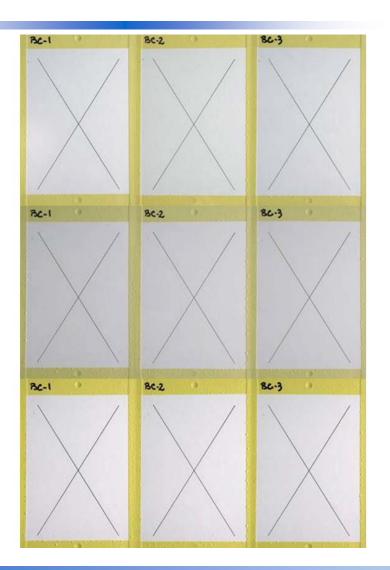
BR&T IZ-C17+ Zn-Ni w/Tri CC Scribed & Painted

336 hours

672 hours

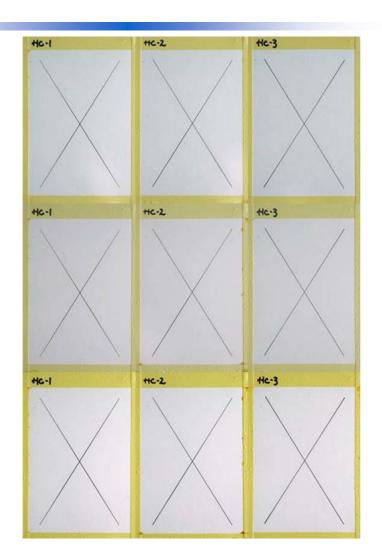
Hill AFB IZ-C17+ Zn-Ni w/Tri CC Scribed & Painted

336 hours

672 hours

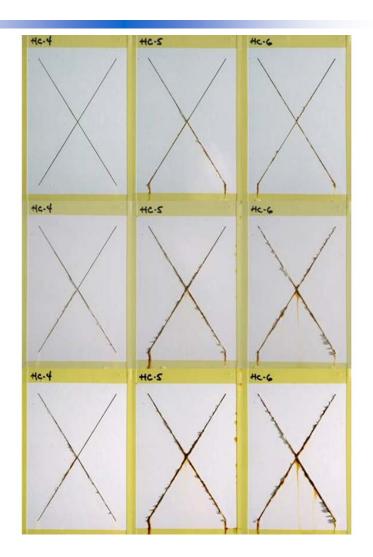
Hill AFB LHE Cd w/Hex CC Scribed & Painted

336 hours

672 hours

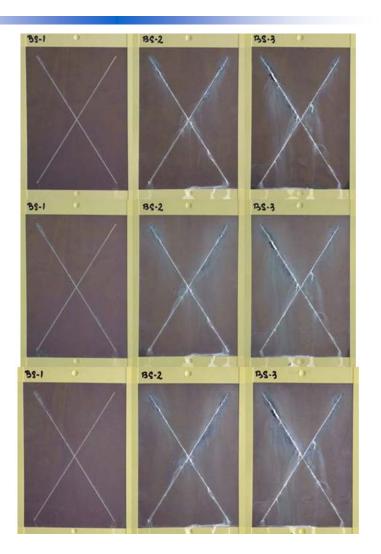
BR&T IZ-C17+ Zn-Ni w/Tri CC Scribed

336 hours

672 hours

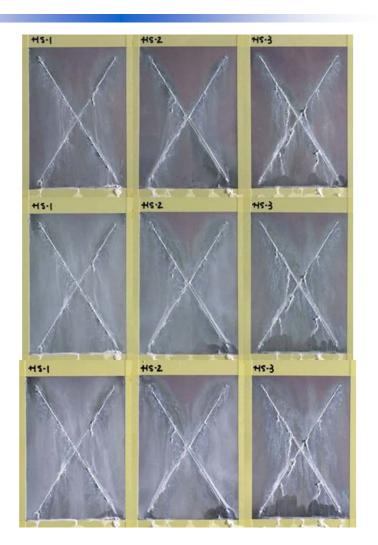
Hill AFB IZ-C17+ Zn-Ni w/Tri CC Scribed

336 hours

672 hours

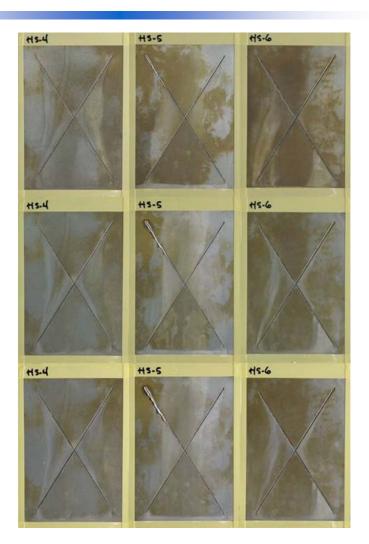
Hill AFB LHE Cd w/Hex CC Scribed

336 hours

672 hours

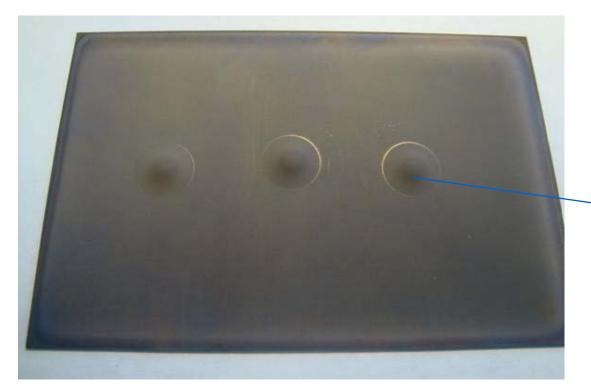
Additional Adhesion Testing LHE Zn-Ni Adhesion Impact Test Result

Impact at 70 in-lbs

Conclusion: Zn-Ni has good adhesion when tested by bend-to-break and impact test methods

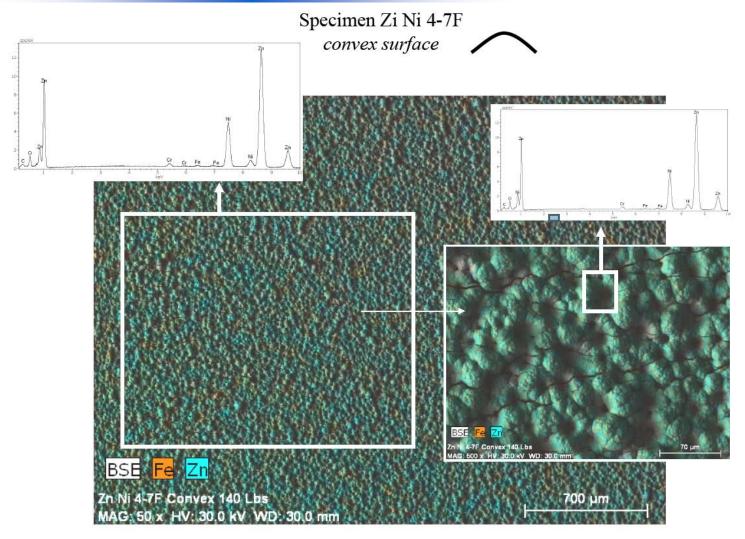
Garner Impact Testing: Zn-Ni

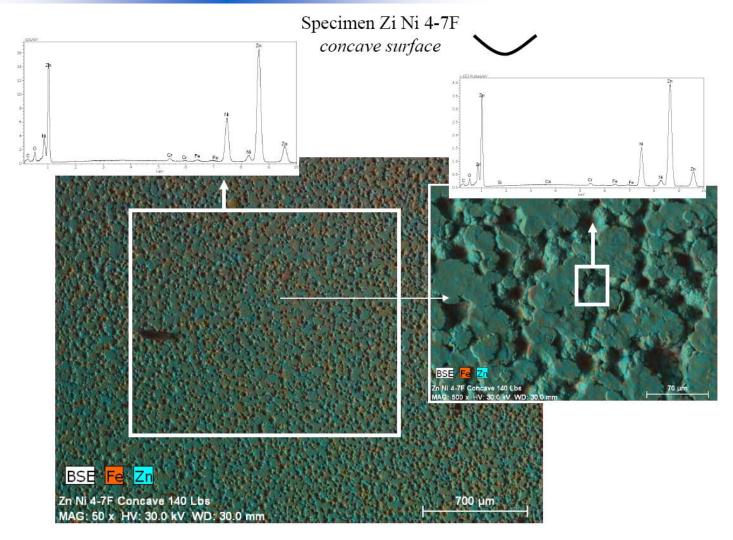
Garner Impact Testing: Zn-Ni

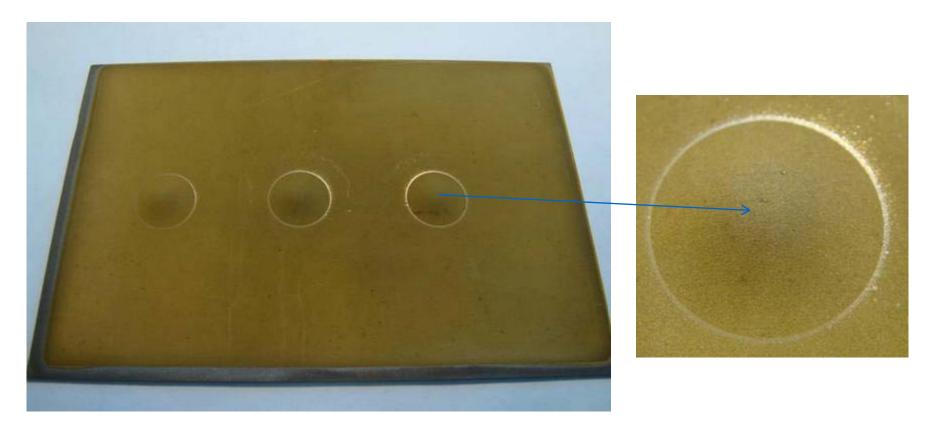
Additional Adhesion Testing Cadmium Adhesion Impact Test Result

Impact at 70 in-lbs

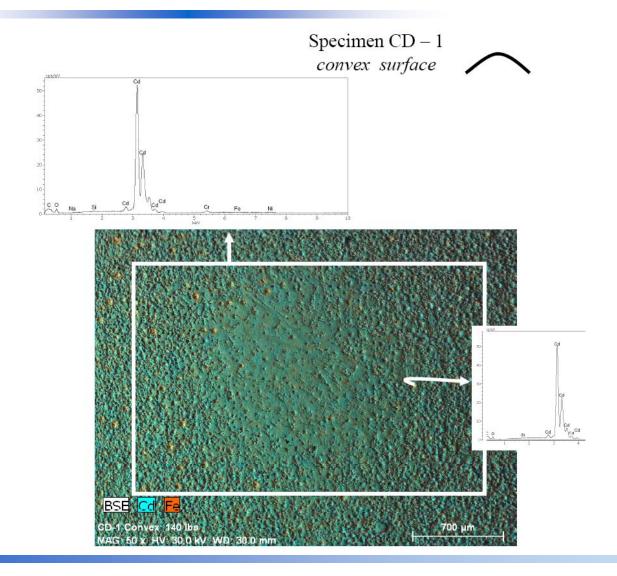
Garner Impact Testing: Cadmium

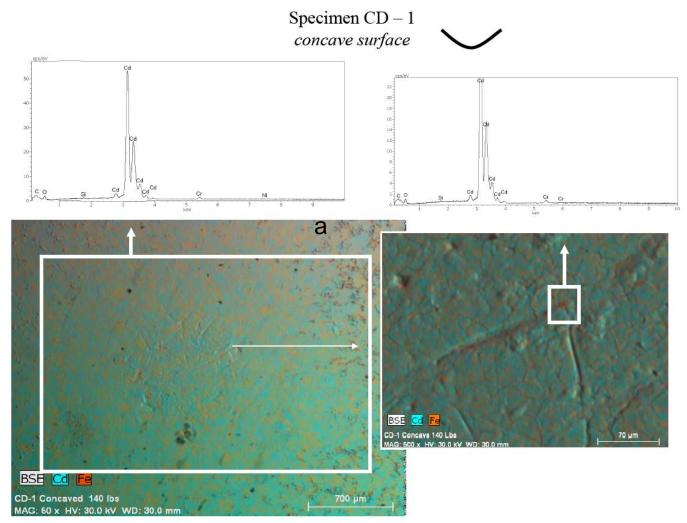
Garner Impact Testing: Cadmium

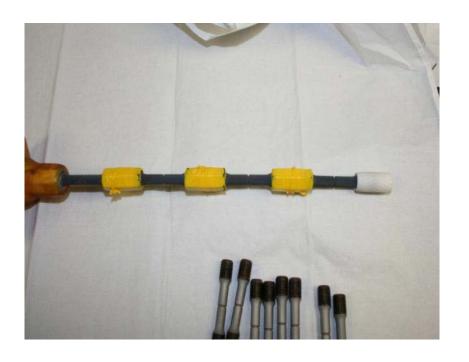
- The original LHE Zn-Ni test coupons failed due to poor plating in notch
- The reason for the poor plating on the original LHE Zn-Ni 1a.1 reembrittlement coupons are as follows:
 - LHE Zn-Ni tank contamination
 - Spring '09 Lab analysis showed organic contamination
 - The PVC tank liner had begun to break down and had to be replaced in the Summer '09 with a more robust grade of PVC liner
 - Two years operating with new liner with no problems
 - Inconsistent plating in notch area
 - Specimens were chained in series when they were plated for the first series of tests
 - Now a fixture and conformal anode is used to ensure that there is uniform plating throughout the notch area per production process specification
 - Also circulation has been added around the notch area during plating

Original Coupons Chained in Series

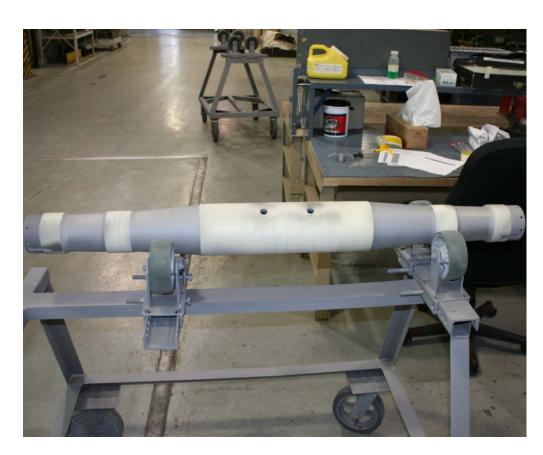
MLG Axle before Fixture

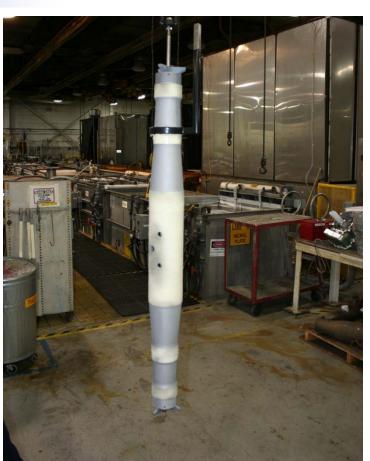
MLG Axle with Fixture

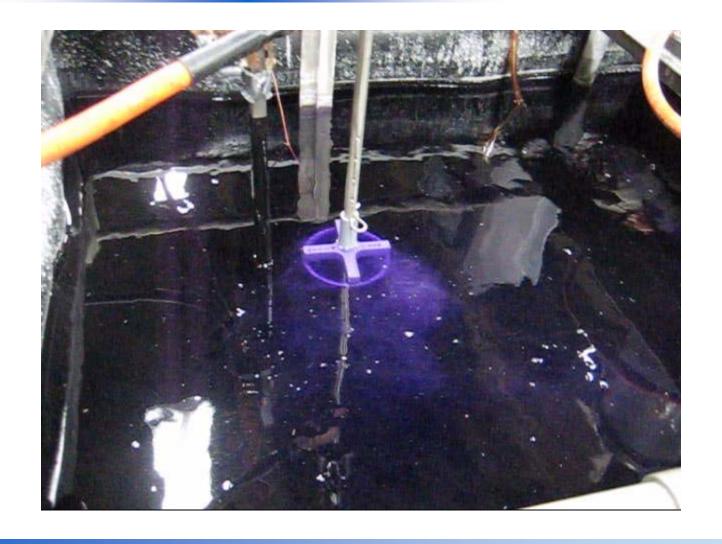
MLG Axle During LHE Zn-Ni Plating

MLG Axle after LHE Zn-Ni Plating

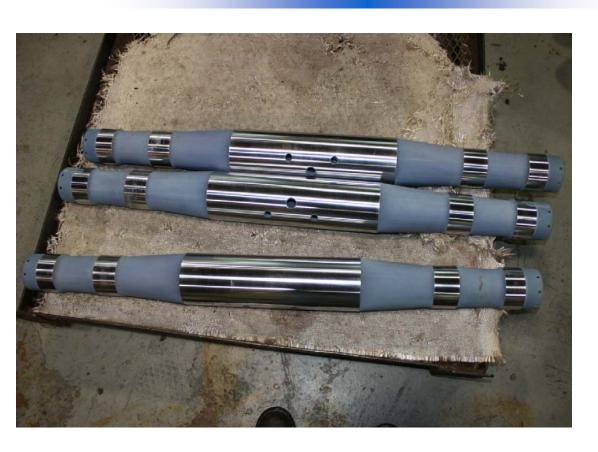
MLG Axle Finished Plated Outer Diameter

MLG Axle Finished Plated Inner Diameter

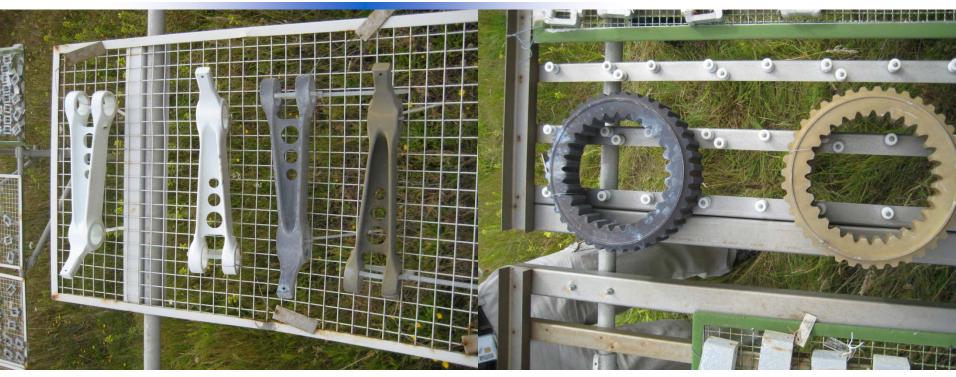
LHE Zn-Ni Plating – Ph III (FY 12) Component Corrosion Eval. (Whidbey Island)

F-15 MLG Lower Drag Brace

C-5 MLG Rotation Collar

Parts Placed 10/13/2010, Pictures taken 7/24/2012

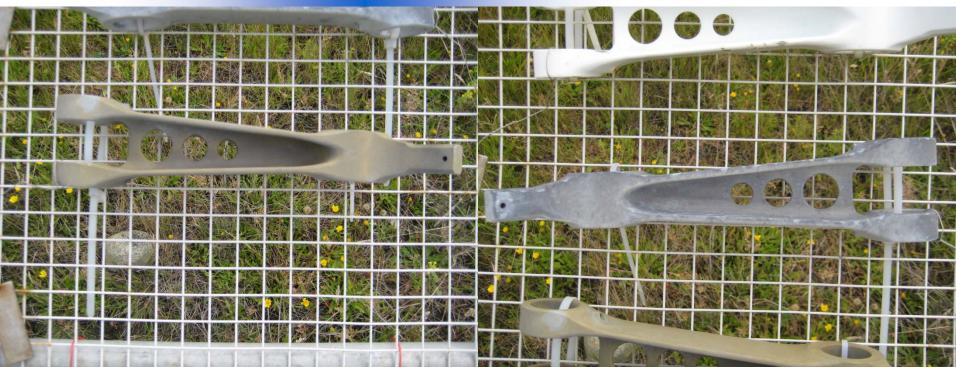
LHE Zn-Ni Plating — Ph III (FY 12) Component Corrosion Eval. (Whidbey Island)

F-15 MLG Lower Drag Brace CAD F-15 MLG Lower Drag Brace Zn-Ni

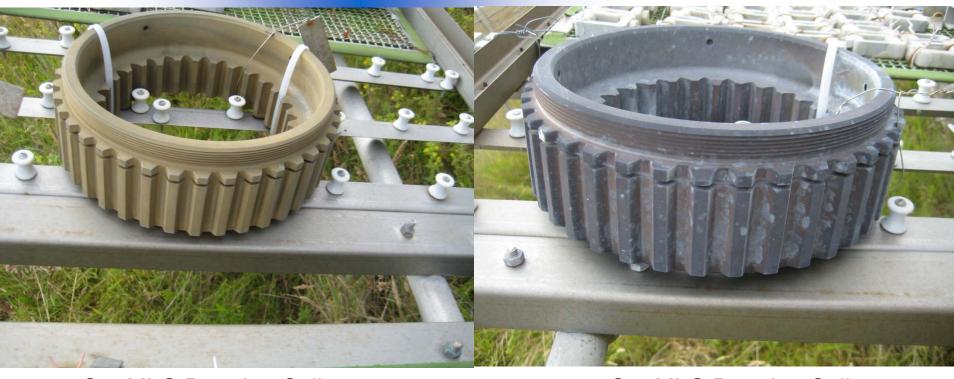
LHE Zn-Ni Plating — Ph III (FY 12) Component Corrosion Eval. (Whidbey Island)

C-5 MLG Rotation Collar CAD

C-5 MLG Rotation Collar Zn-Ni

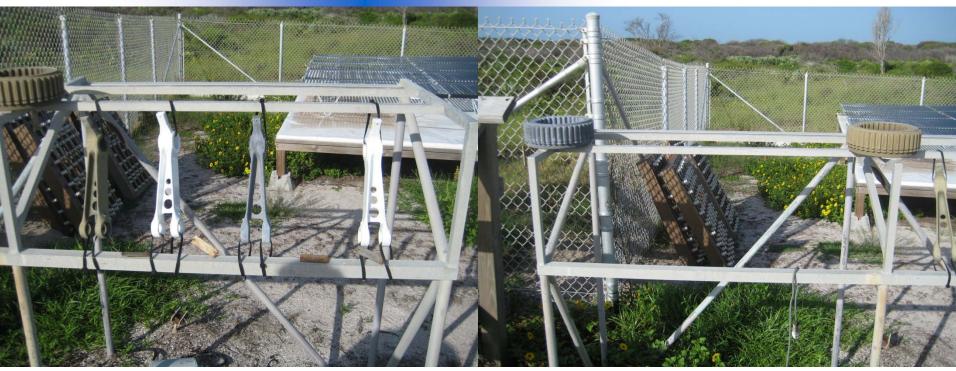
LHE Zn-Ni Plating — Ph III (FY 12) Component Corrosion Eval. (Cape Kennedy)

F-15 MLG Lower Drag Brace

C-5 MLG Rotation Collar

Parts Placed 9/30/2010, Pictures taken 8/07/2012

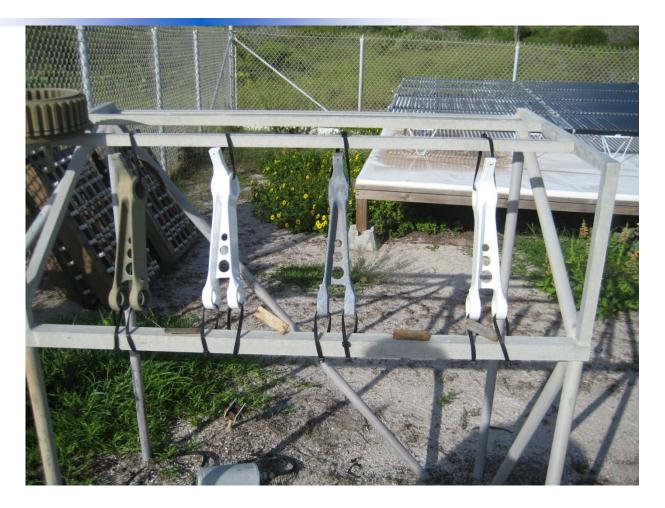
LHE Zn-Ni Plating — Ph III (FY 12) Component Corrosion Eval. (Cape Kennedy)

F-15 MLG Lower Drag Brace CAD

F-15 MLG Lower Drag Brace Zn-Ni

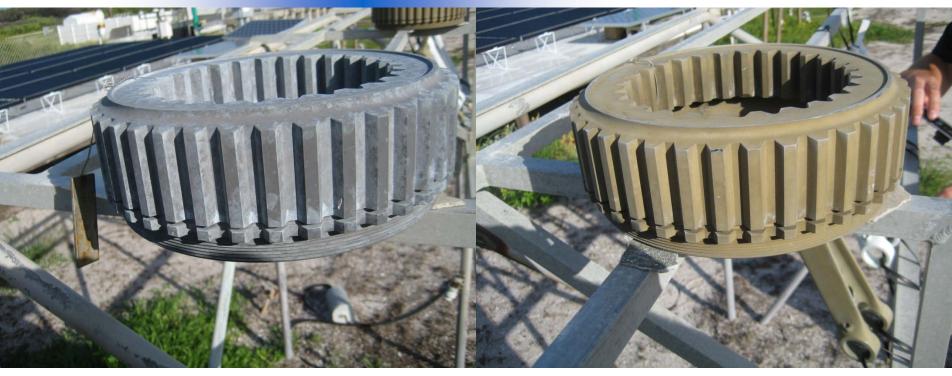
LHE Zn-Ni Plating – Ph III (FY 12) Component Corrosion Eval. (Cape Kennedy)

C-5 MLG Rotation Collar CAD

C-5 MLG Rotation Collar Zn-Ni

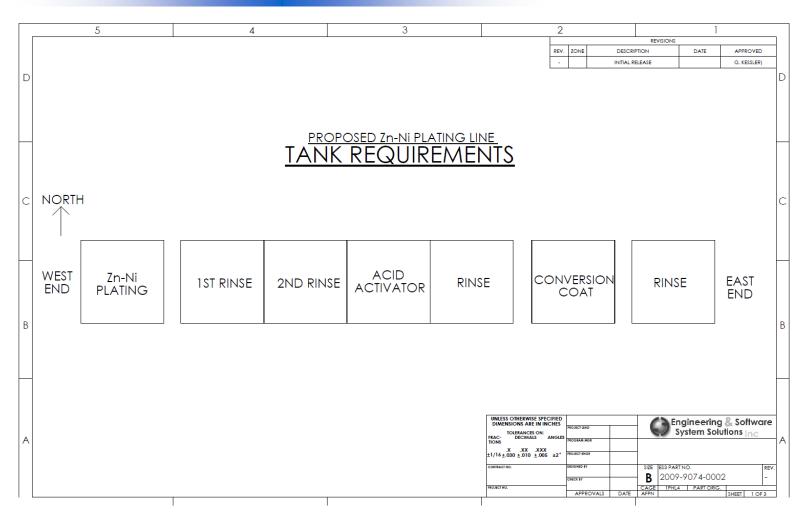
ESTCP/P2/STTP Effort Full Size Prototype Plating Line

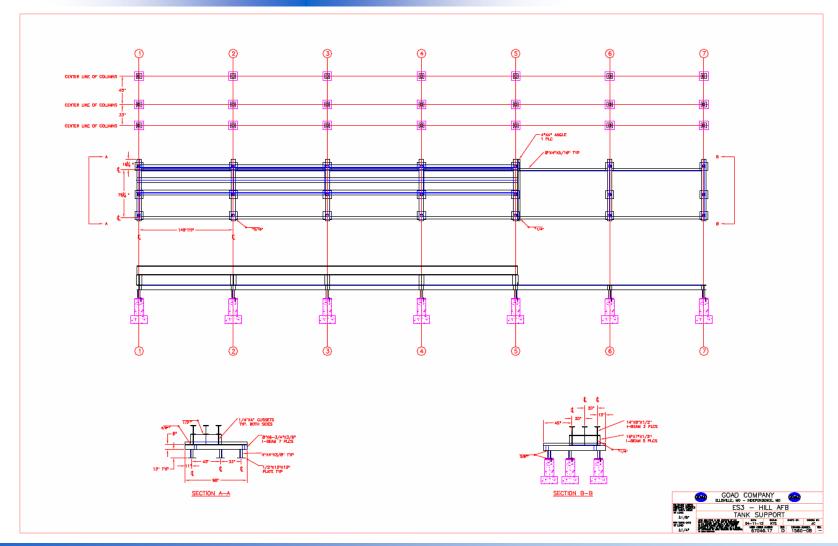
LHE Zn-Ni Preliminary Tank Structure Drawing

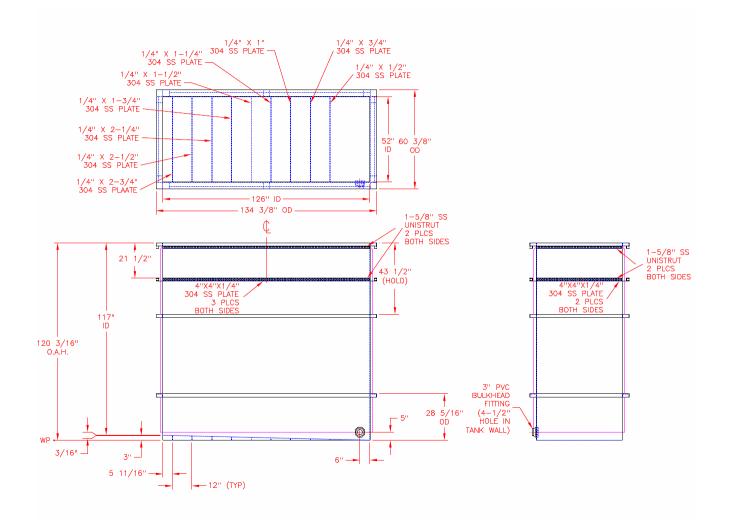
LHE Zn-Ni Prototype Plating Line Tank Drawing

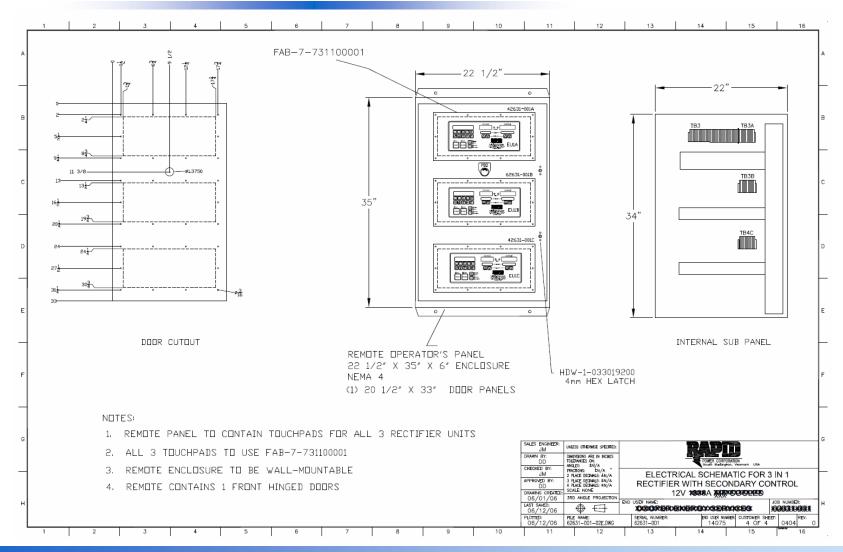
LHE Zn-Ni Prototype Plating Line Rectifier Controller

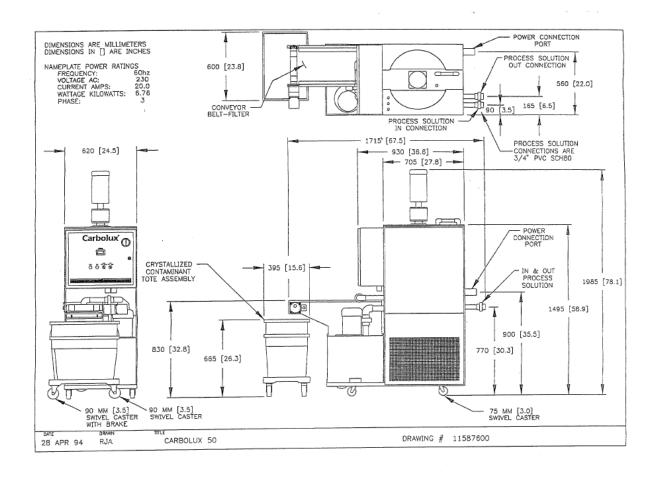
LHE Zn-Ni Prototype Plating Line CarboluxTM System

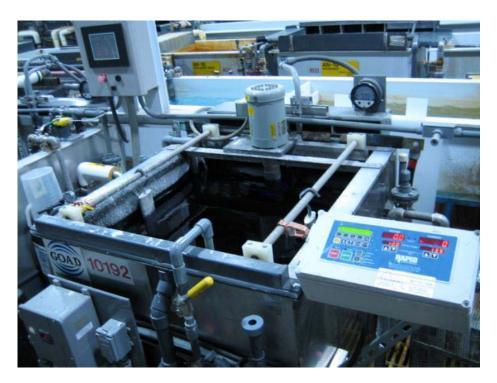
- ES3 has implemented a tank of approximately 325 gallons for the purpose of demonstrating the LHE Zn-Ni plating process on some full sized gear components
- The demonstration tank was used to develop uniform plating thicknesses and process parameters on test coupons and full scale landing gear components
- During the plating operations Quality Assurance testing has been conducted to ensure the alkaline LHE Zn-Ni solution is within proper process limits

LHE Zn-Ni Plating Tank

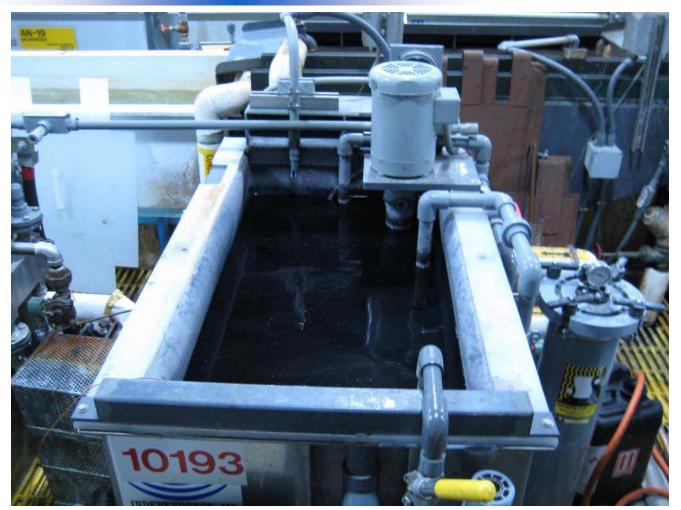
Tri-Chromium Conversion Coat Tank

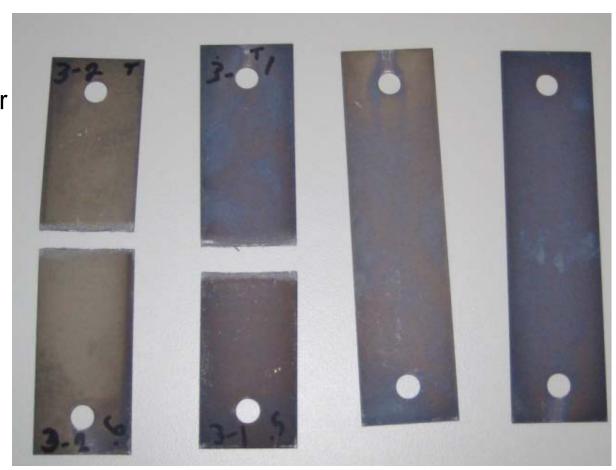
- Adhesion of the LHE Zn-Ni coating to the substrate was tested per ASTM B571
- All adhesion test coupons were manufactured from 1"x 4"x 0.040" 4130 steel sheet
- Results: All Test coupons passed

Adhesion Test Coupons

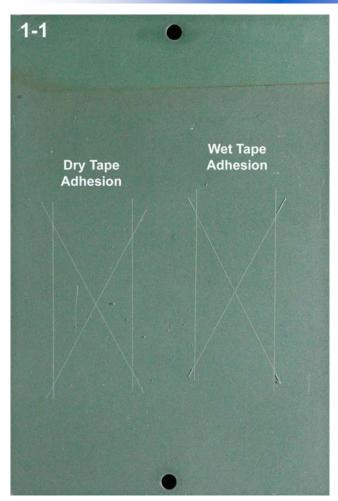
LHE Zn-Ni Test Panels After Dry and Wet Tape Adhesion Test of Primer (Passed)

Deft 44-GN-072

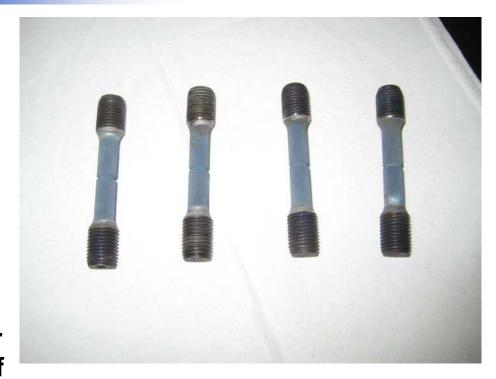
- Coupons manufactured per ASTM F519 specifications (4340)
- Coupons plated and tested 28th April, 2009 upon initial installment of LHE Zn-Ni demonstration tank
- Additional coupons plated and tested at additional dates
- All coupons tested per ASTM F519 and passed the 200 hour sustained load tests @ 75% of the tensile notch fracture strength

ASTM F519 Type 1A.1 Test Coupons

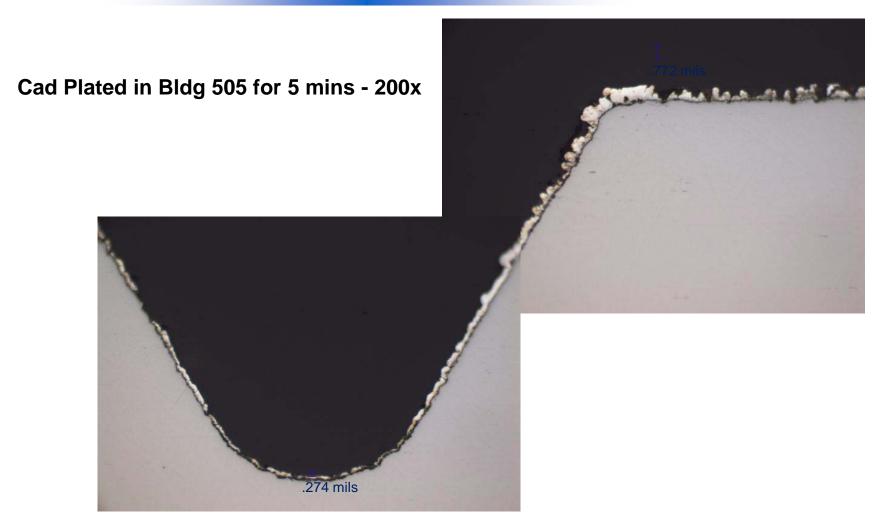
HE Plated Cross Section

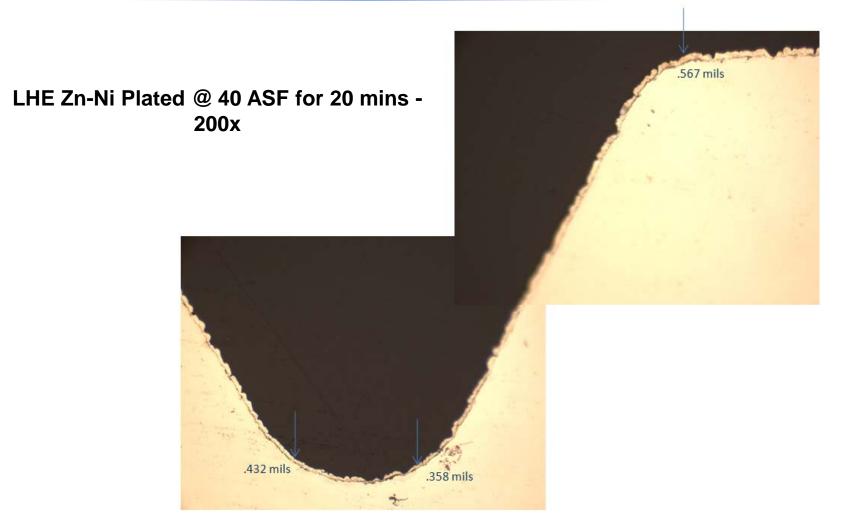
HE Plated Cross Section

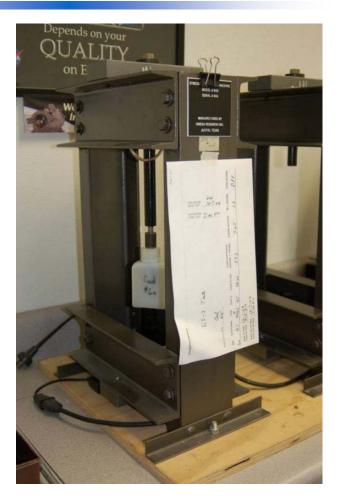
LHE Zn-Ni Re-Embrittlement Testing Machine

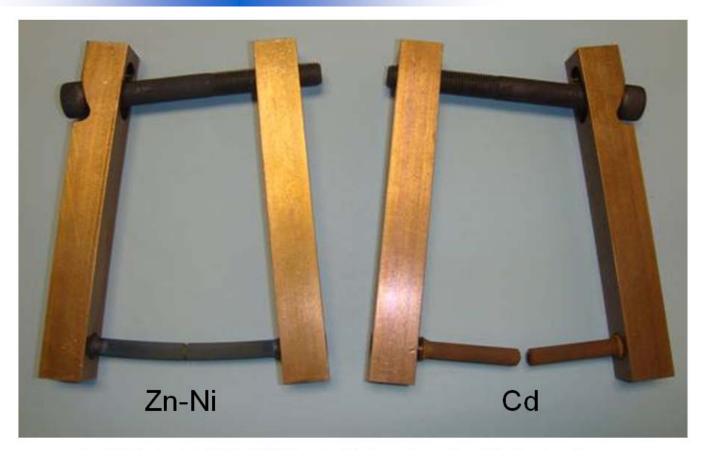
LHE Zn-Ni Plated and Cad Plated 300M Type 1a.1 Test Specimens in Self-Loading Bend Frames

- Liquid and Solid Metal Embrittlement (LME and SME) occur when one metal, either as a liquid or solid, intrudes into the structure of another, potentially causing embrittlement in the base metal
- Melting points for the coating metals are as follows:
 - Cadmium ~610°F
 - Zinc ~787°F
 - Nickel ~2650°F

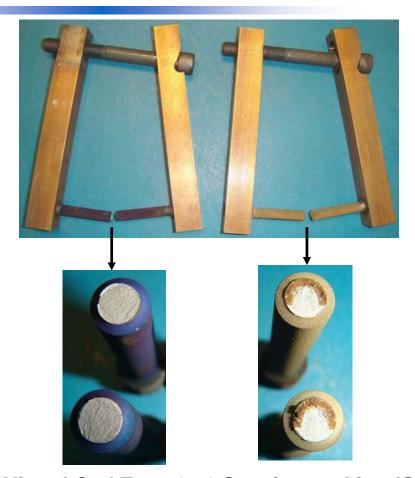
Temp/NFS	Material	Zn-Ni 200Hr	Cad 200Hr	Zn-Ni Step Load	Cad Step Load
600F/85%	300M	Pass	Fail	100% NFS	-N/A-
500F/85%	300M	Pass	Fail	100% NFS	87% NFS
400F/85%	300M	Pass	Fail	100% NFS	91% NFS
400F/75%	300M	Pass	Fail	100% NFS	81% NFS

LHE Zn-Ni and Cad Type 1a.1 Specimens After ISL Test to Determine the NFS After Exposure to 400°F for 200 Hours

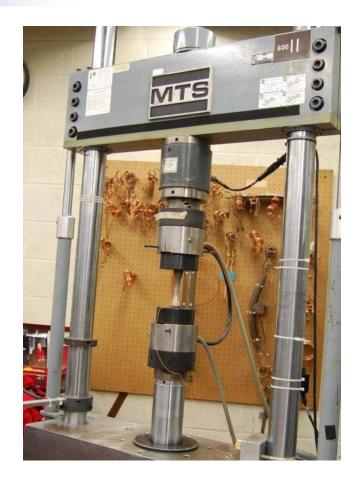
Phase I Fatigue Testing (Shotpeened Coupons)

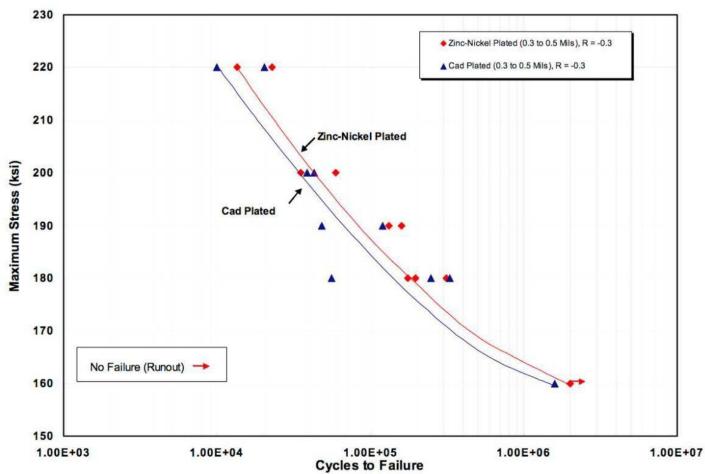
C-17 P2 Program Fatigue Data

(IZ-C17 with Hex conversion coating)

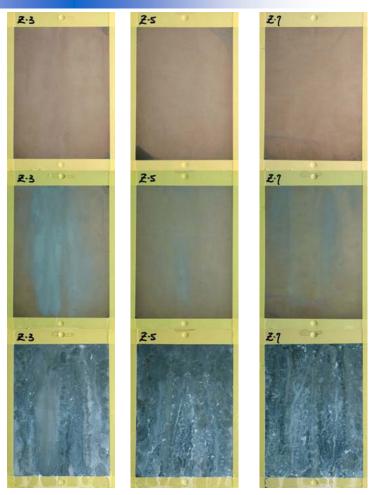
IZ-C17+ Zn-Ni with Trivalent Chrome Conversion Coating Unscribed – ASTM B Figure 4

1000 hours

3000 hours

5000 hours

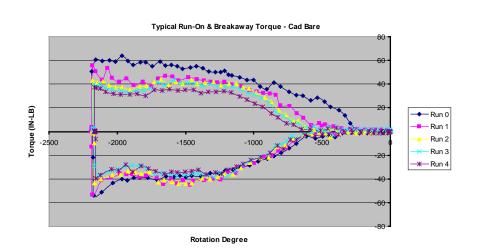
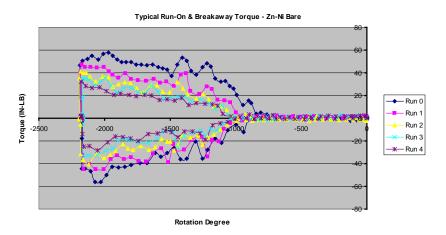
Torque Tension

- Robins AFB Cad plating replacement on threaded fastener and components
 - Typical chart for run on break away test showing Cad vs. LHE Alkaline Zn-Ni

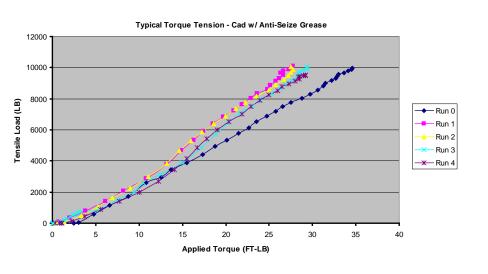
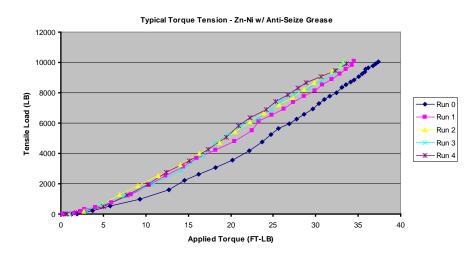
Torque Tension

- Robins AFB Cad plating replacement on threaded fastener and components
 - Typical chart for Torque Tension Test showing Cad vs. LHE Alkaline Zn-Ni with MIL-PRF-83483 Anti-seize grease lubricant

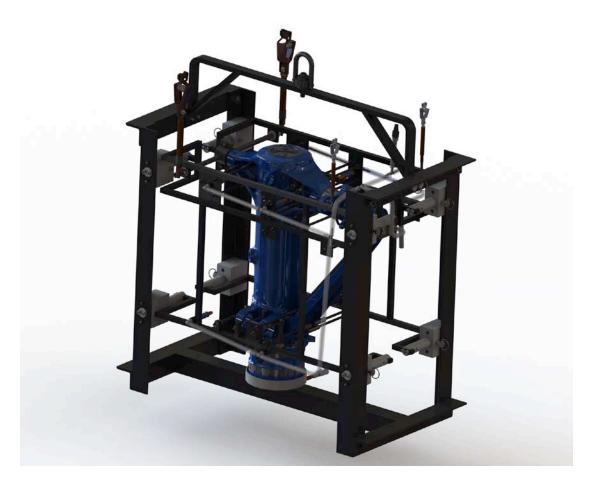
LHE Zn-Ni Conformal Anode and Fixture Models

MLG Outer Cylinder

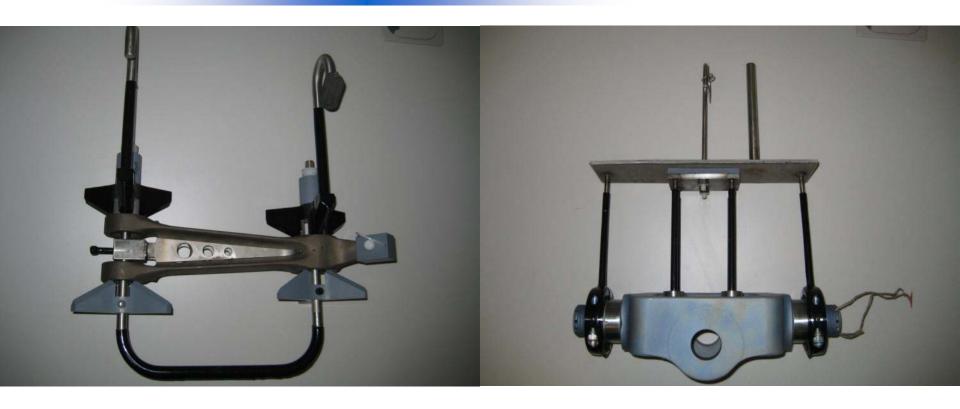
LHE Zn-Ni Completed Fixtures

MLG Lower Drag Brace

NLG Gimble Ring

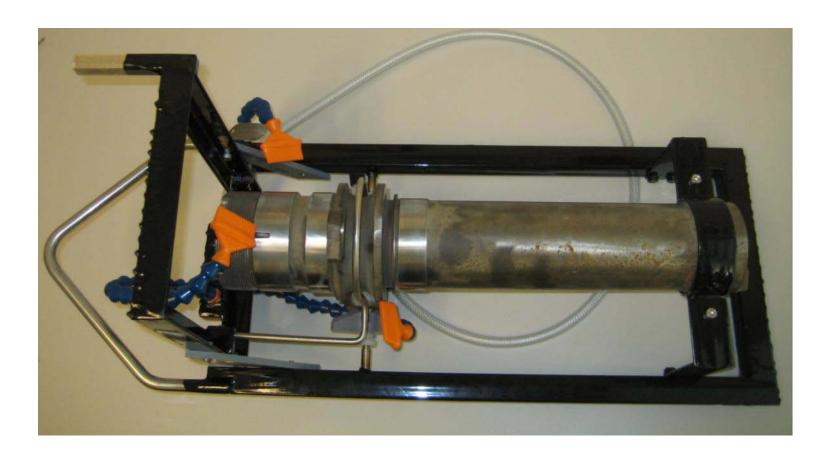
LHE Zn-Ni Completed Fixture

NLG Inner Piston
